#### **HPT Data**

#### **HPT Log**

LCCS Reference Materials

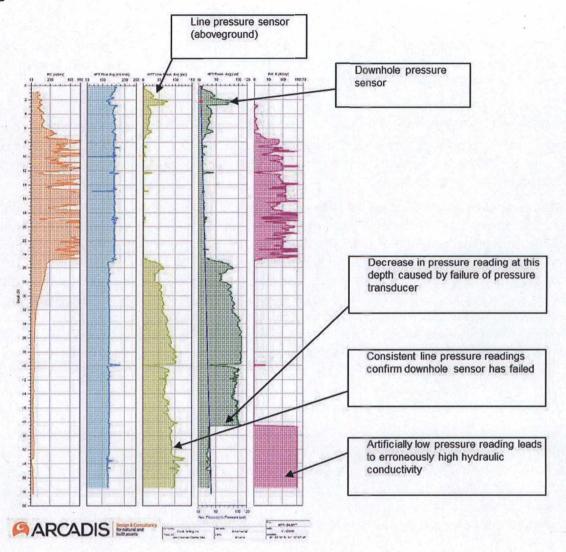
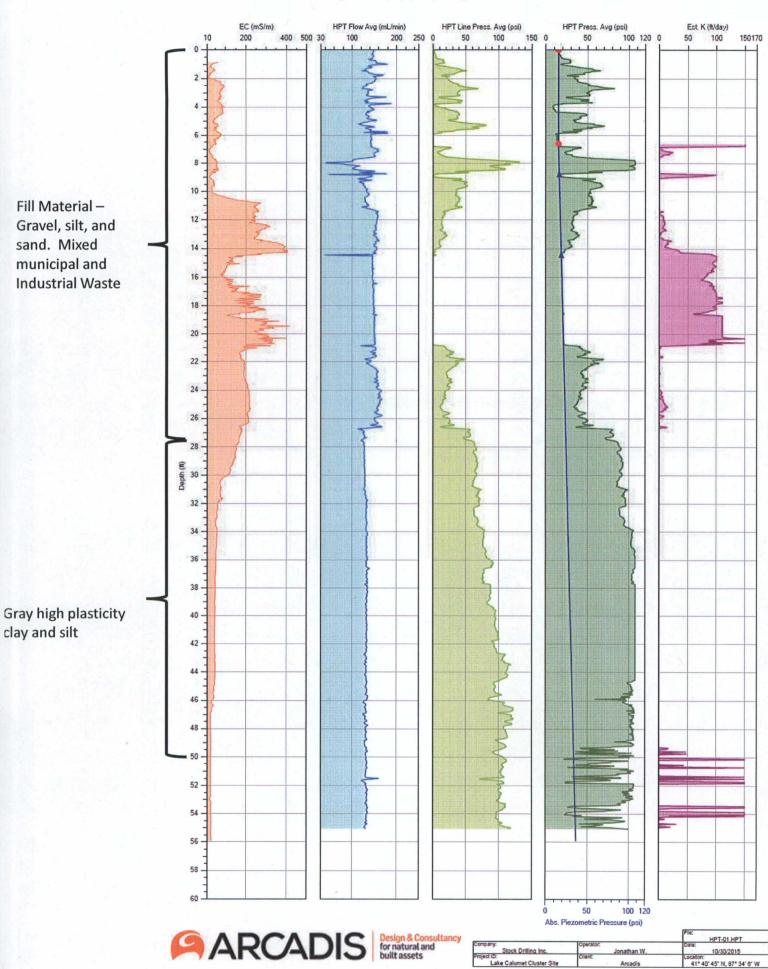
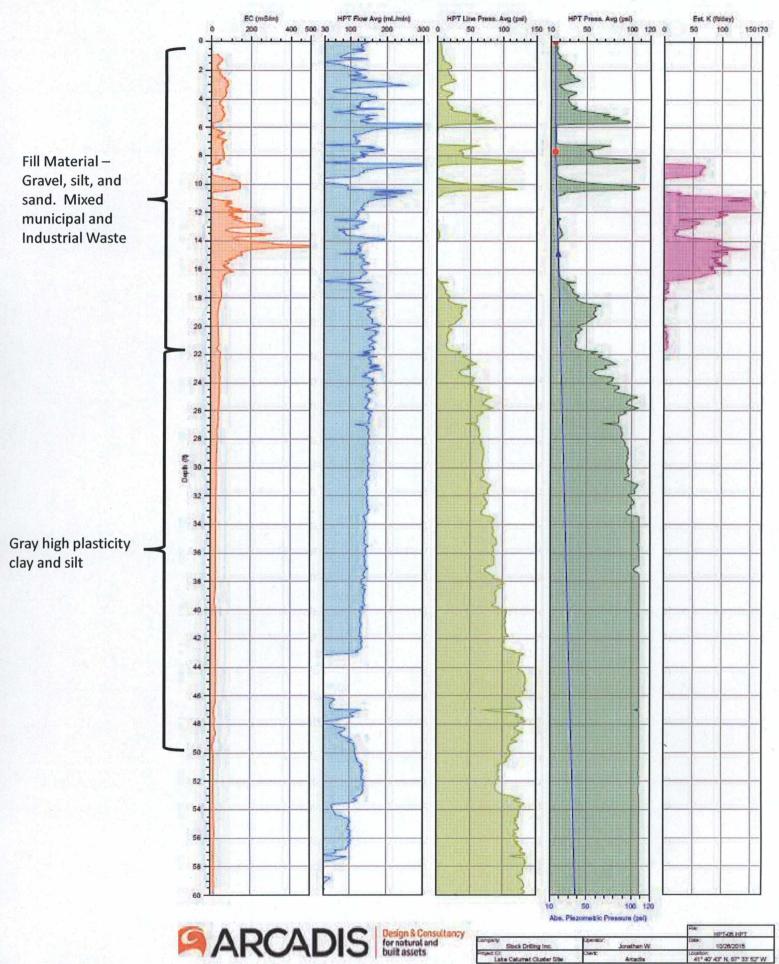
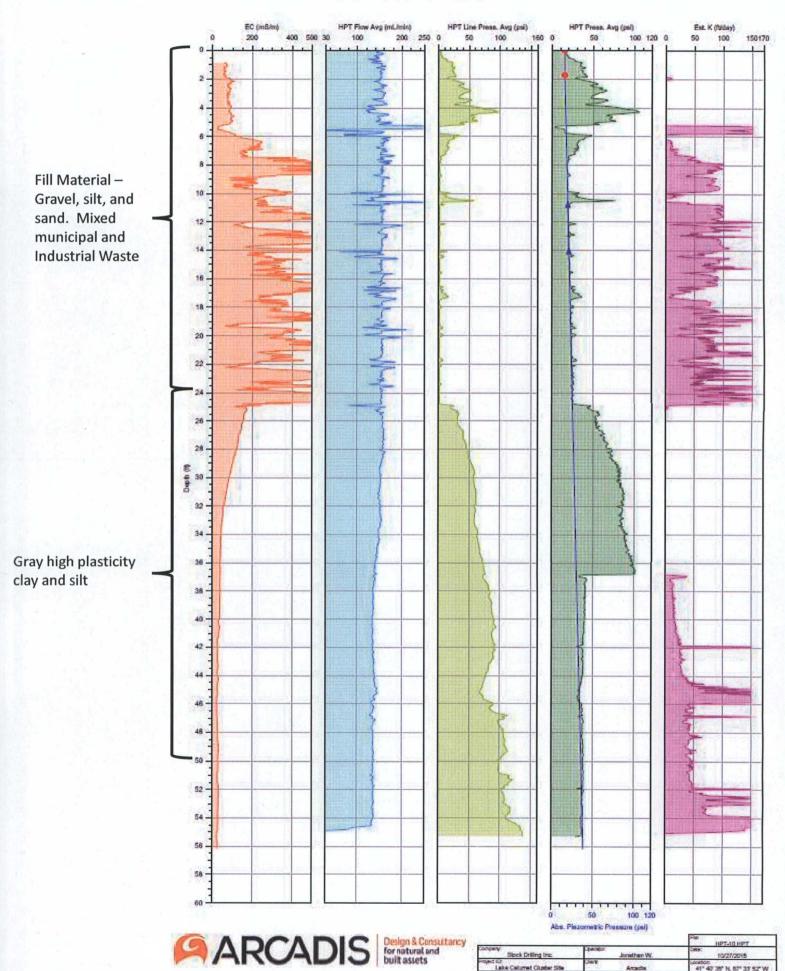
The appearance of a higher-permeability unit in these logs is an artifact of a pressure sensor failure within the HPT equipment, and review of all the sensor data presented in the logs indicates that a permeable unit is not present at the depths in question. When HPT-01, HPT-10, and HPT-10A were completed in 2015, the Arcadis geologist noted that drilling conditions at these locations were more difficult than elsewhere on the Site, leading to greater wear on equipment. In particular, at location HPT-10, the drilling crew noted that the pressure sensor within the drilling tooling failed at a depth of approximately 48 to 49 feet below ground surface (bgs) and required replacement after the boring was complete. A second boring, HPT-10A, was attempted at an adjacent location to obtain more representative pressure data, but a similar sensor failure occurred. The pressure sensor failure resulted in a higher reported estimate of relative hydraulic conductivity on the HPT log, as shown below. The geologist determined that a unit with a higher silt content was present at these locations and depths, which was causing transducer failure and, thus, HPT logs that were not representative of the true geological conditions.

The attribution of this issue to the pressure sensor failure was confirmed through review of the "line pressure" sensor output on the HPT equipment to the downhole pressure reading on the HPT tooling. The line pressure and downhole pressure sensors both track hydrostatic pressure within the water injection line that runs to the downhole injection port and provide similar relative pressure readings when both sensors are functioning normally. In the case of HPT-01, HPT-10, and HPT-10A, a divergence in the two sensors' output is noted at depth, corresponding to failure of the downhole sensor.
